Assessment Strategies for PFAS Case Study for the Blades Groundwater Site

U.S. EPA, Region 3

By: Connor O'Loughlin

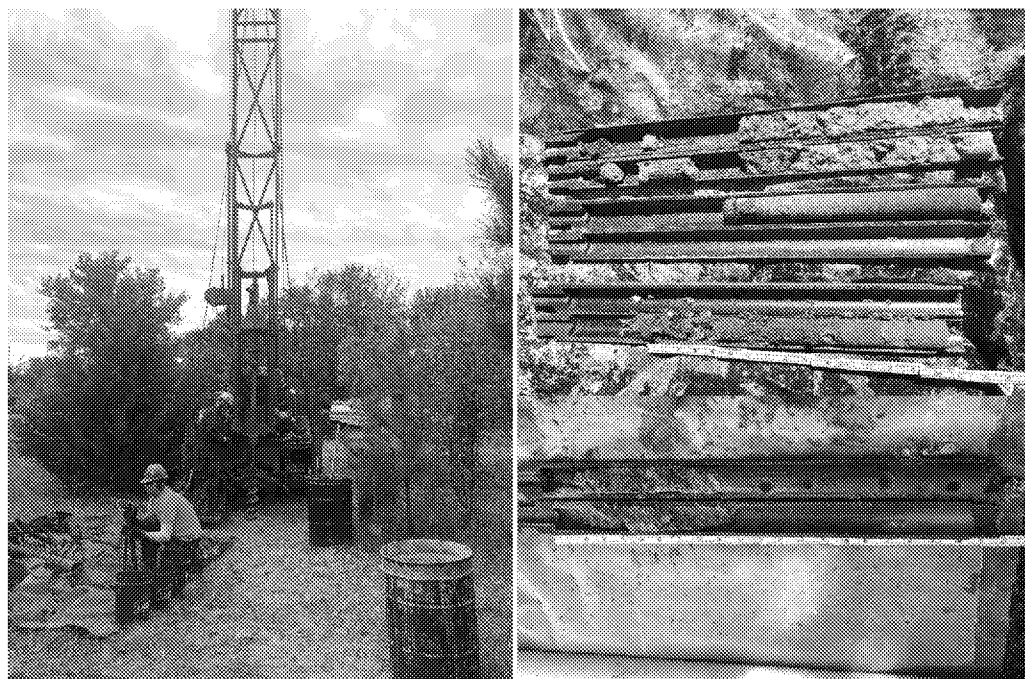
Site Assessment Photographs

Compared with limited groundwater aquifer results, high-risk zones identified in the geospatial evaluation were proximal to drinking water wells with detectable PFAS concentrations. EPA completed academic and technical research of the geology, hydrogeology, and chemistry of Fumetrol 140 prior to the SI.

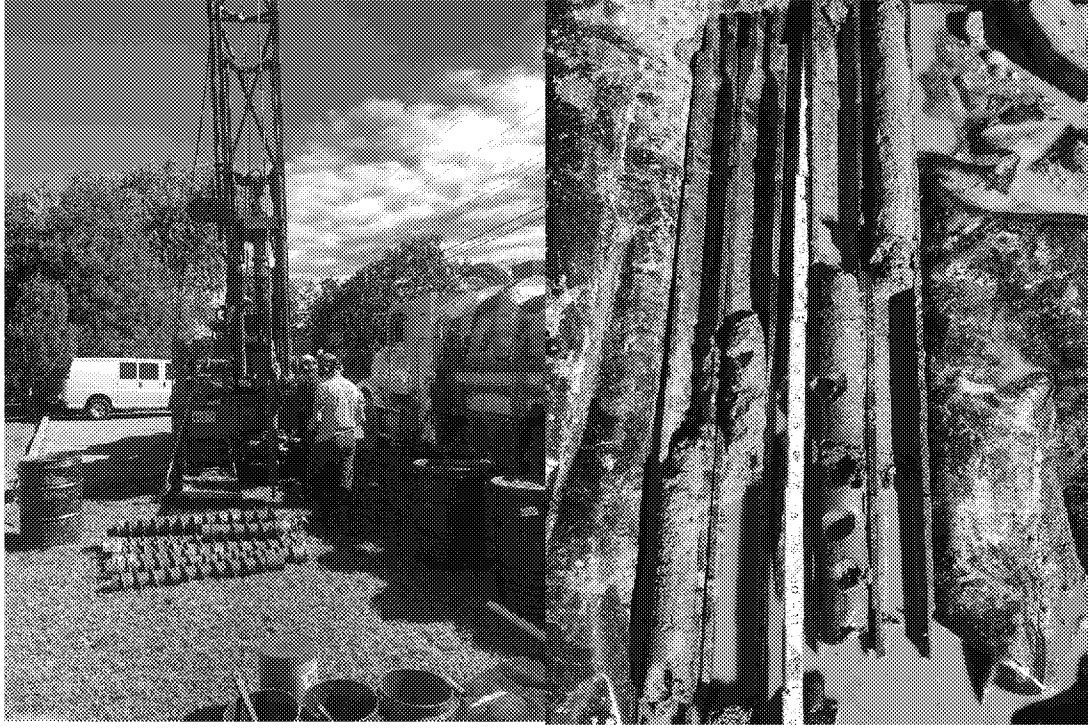
Site Assessment Photographs

Photo on the left, standard auger and split spoon drilling method. I wanted to use methods which would limit the potential for cross contamination of the groundwater samples. The drillers used only steel items and standard metal tooling.

Photo on the right slit spoon to 45-47 feet sand on top with dark gray clay layer. Set the well into the sand. I attempted to obtain the best lithological controls knowing that PFAS would not sink or sorb like other organic compounds but will flow on top of the clay layers.

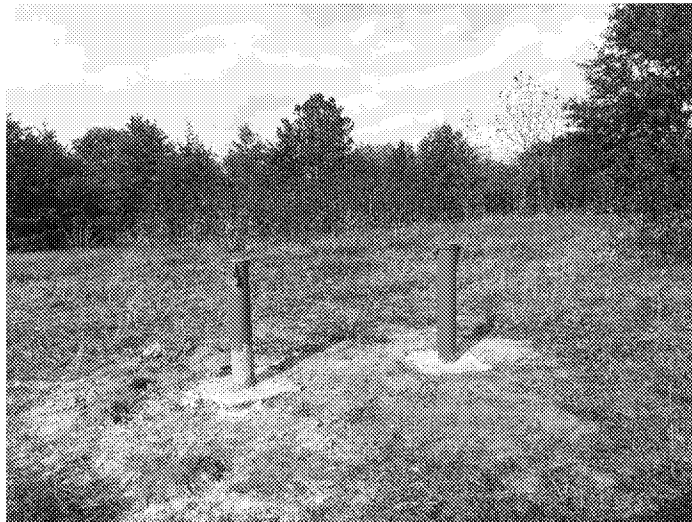
Site Assessment Photographs

Completed groundwater monitoring wells for the SI investigation, down gradient wells over 3000 feet from the sources.

My overall strategy took into account larger distances than typical contaminants, potential flow velocity equaling water and multiple directions. Contamination was found in the stream and sediments 3500 feet down gradient from the site. Due to the longevity of PFAs substances in the environment I had to consider long periods of time to ensure EPA's protects human health and environment.
